# Seaworthy Inspection Report

**Certificate of Seaworthiness #1111**

Job # 1111  
22nd March 2022

Boat Identification    Stejcraft islander 580  
OB Rego: TJ 7437  
HIN: AUSTE05230I718

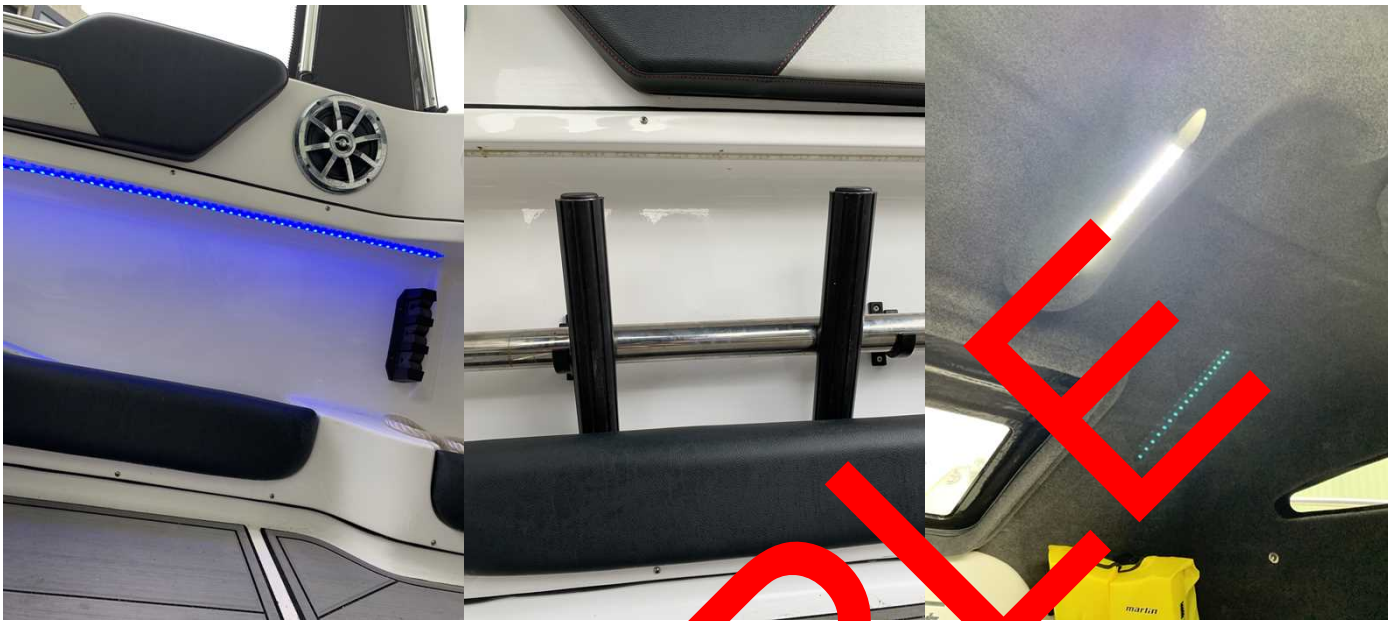
**Cabin/Deck Lighting Condition**      **Requires Attention**  
**Portside deck lighting working only starboard side not**

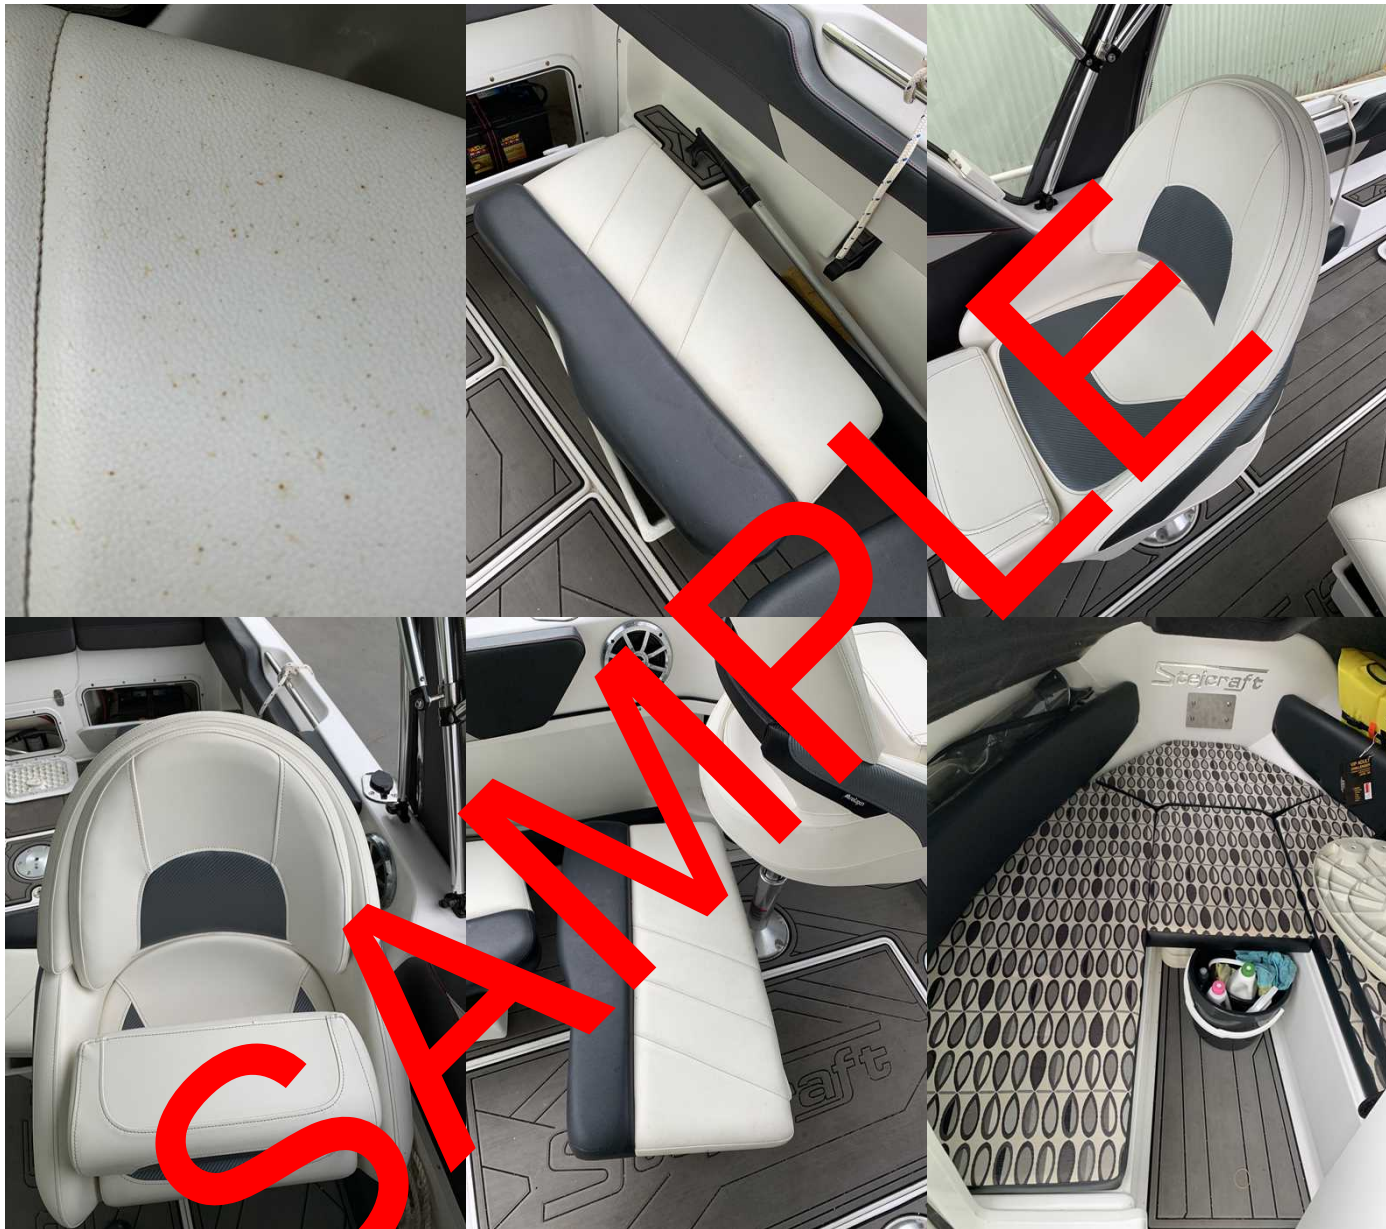
**Seats & Trim**    **Requires Attention**  
**Fair to good condition**

Rust pickle marks on rear seating left side.

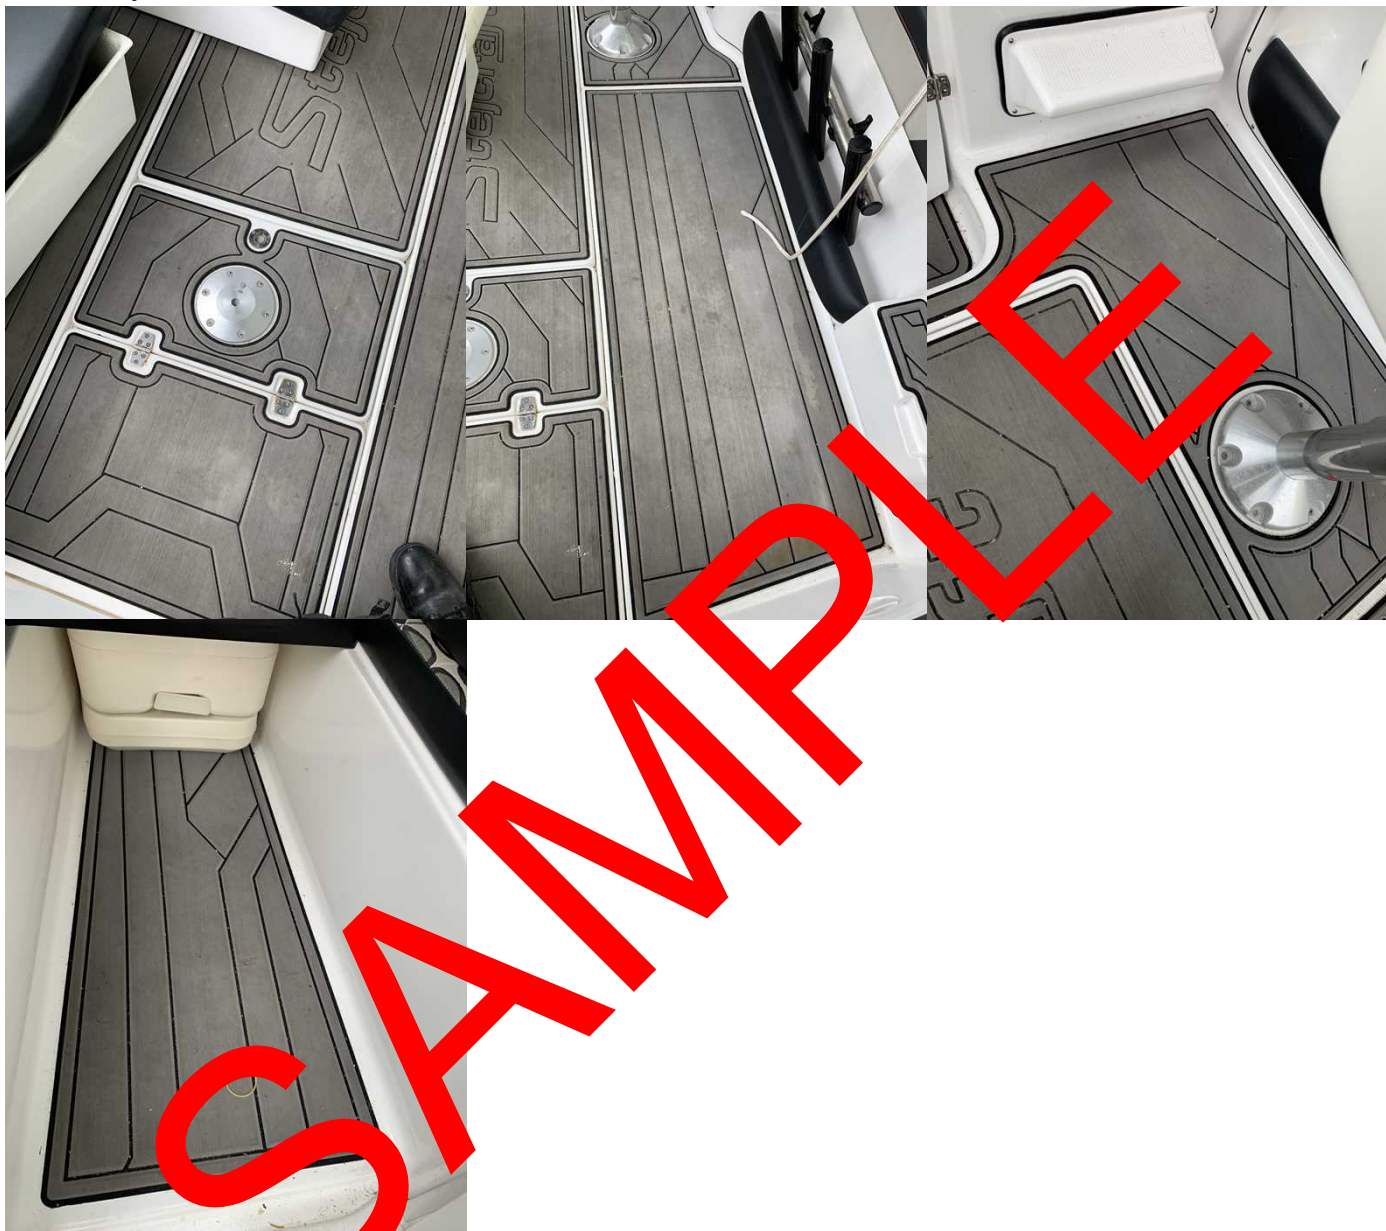
Type      **Seadeck foam**  
Condition      **Requires Attention**  
Dirty - intact and stuck down well

Some rusty stains

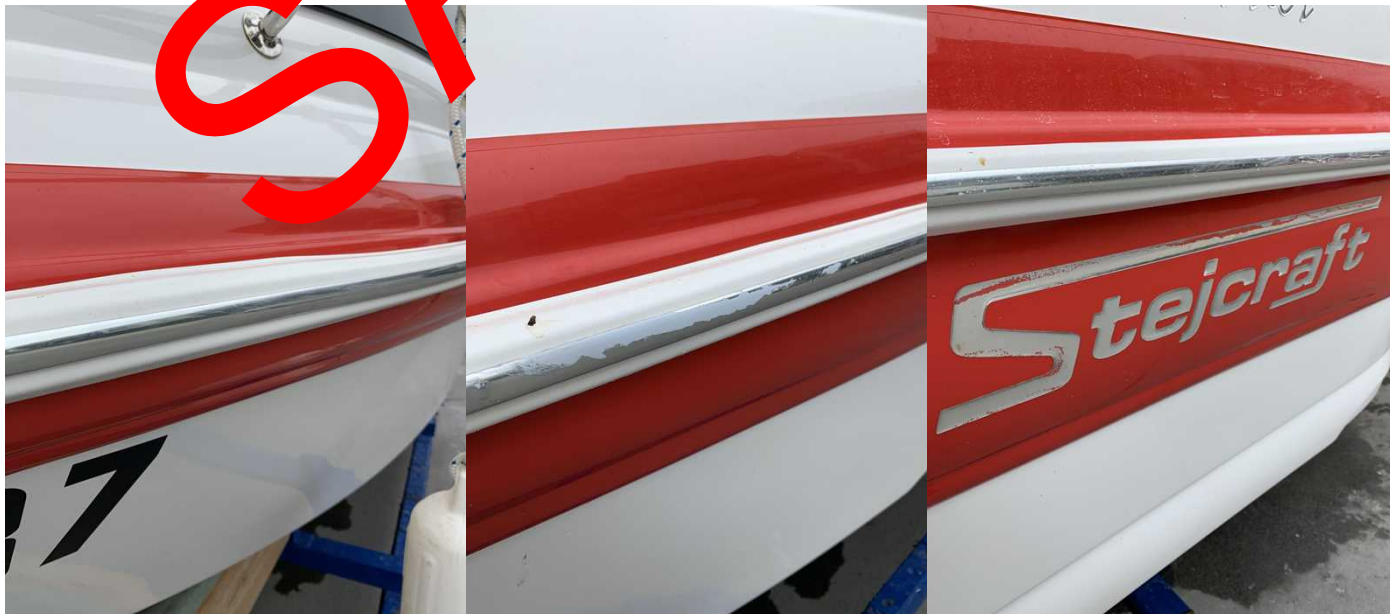
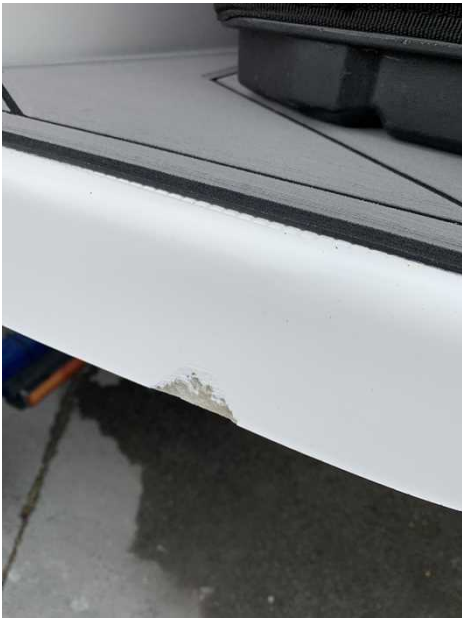
**Port Hull defects, cracks, holes** Requires Attention

Minor spread on gunwale from impact

Stejcraft decal deteriorating

Abrasion on rear corner

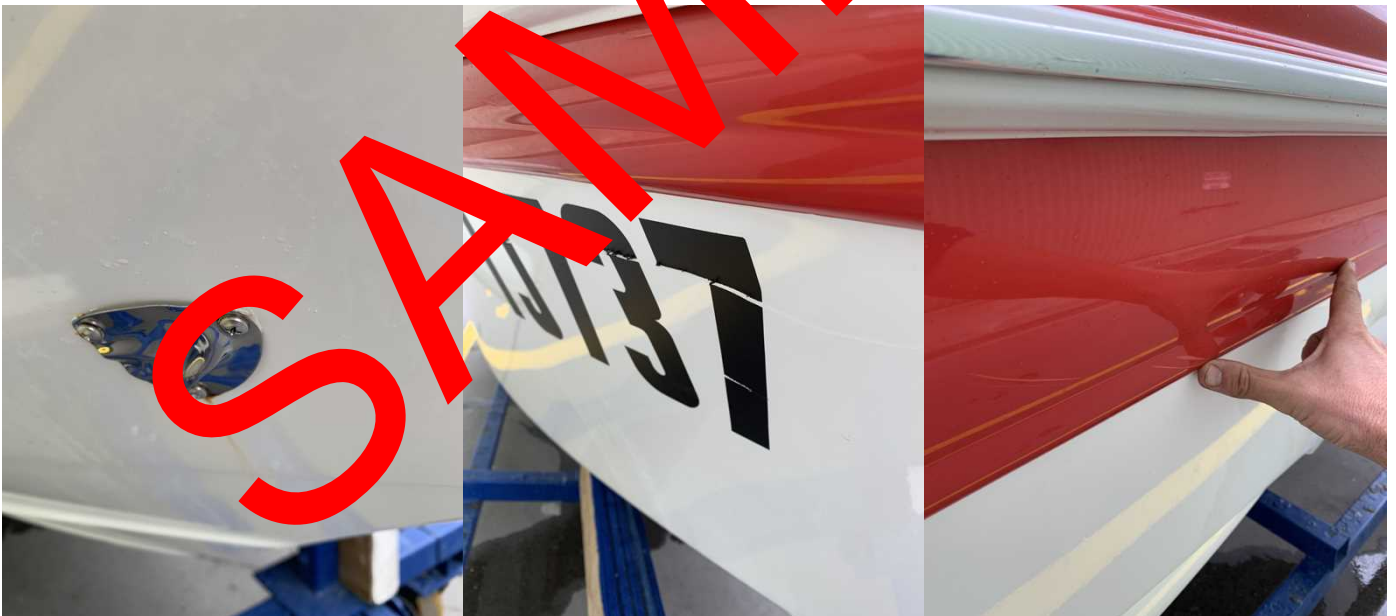
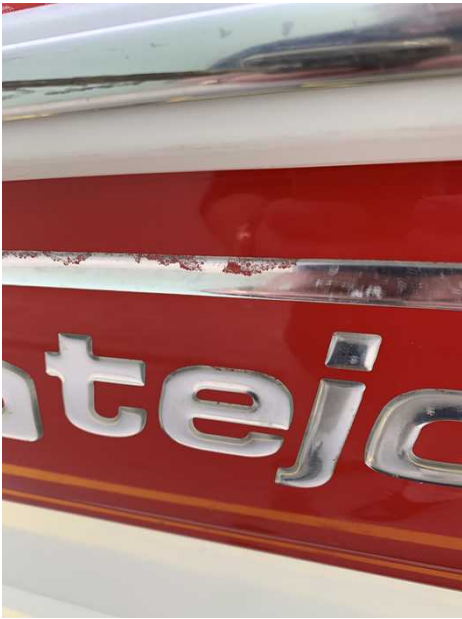
**Starboard Hull defects, cracks, holes etc.**  
**Anchor drain vent squashed**  
**Scratches**

**Requires attention**

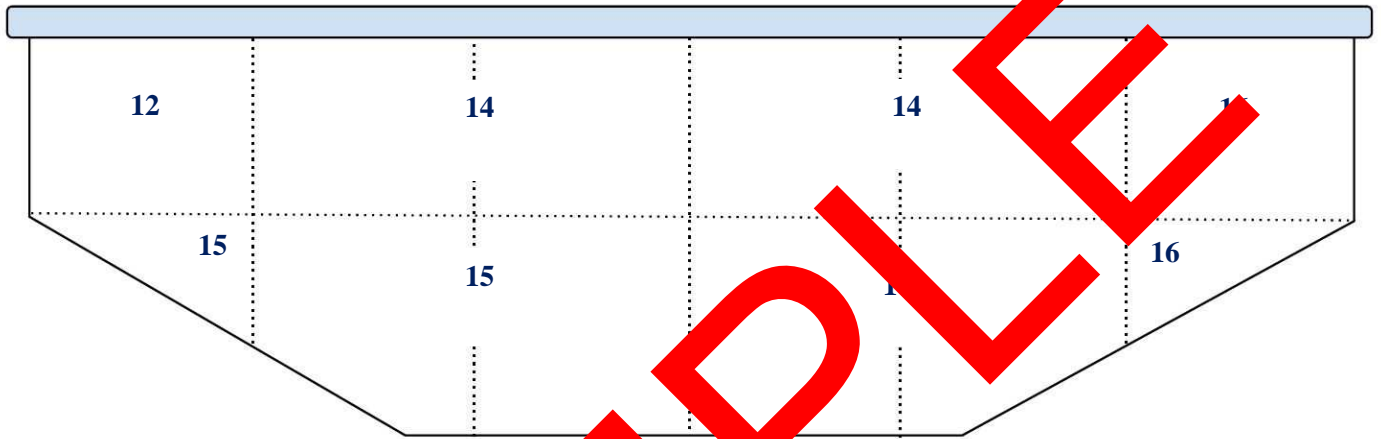
TRANSOM COMPARATIVE MOISTURE TEST %

Overall: **Low**

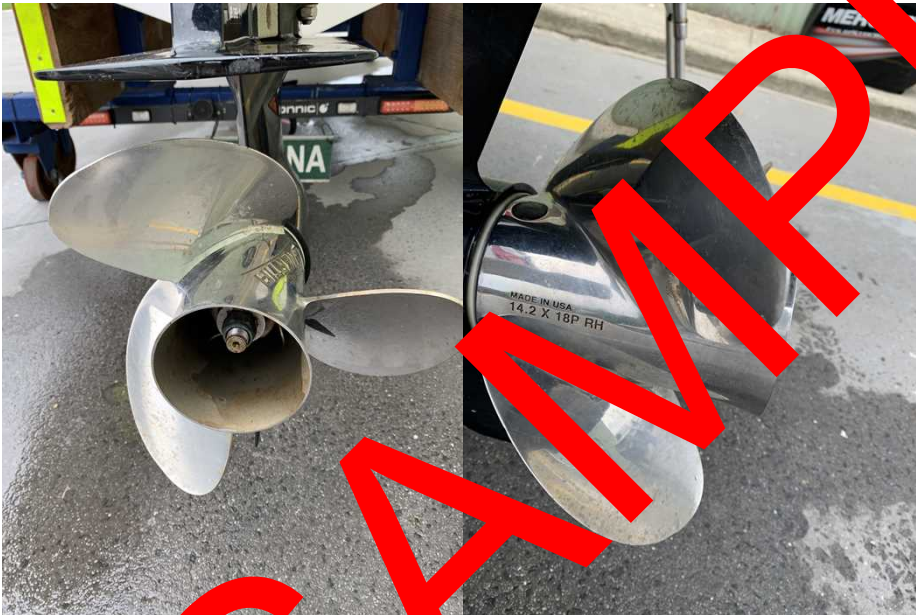
**Propeller/s**  
Construction **Stainless Steel**  
Pitch **18p RH**  
Condition **OK**

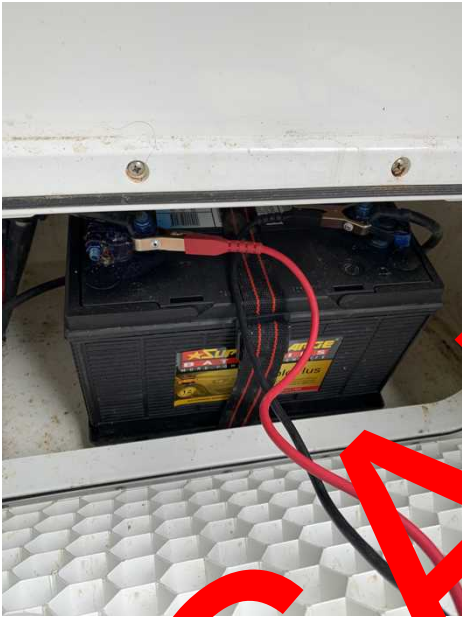
## Battery CCA Rating/s Starboard batt no.1 failed

Rating: 1000 Tested: 763

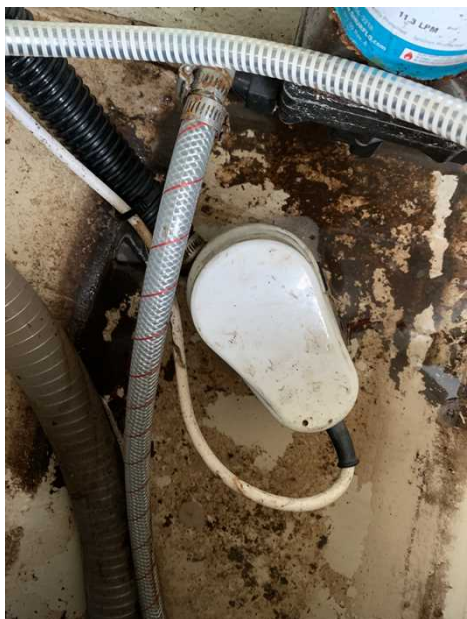
Bilge Pump condition **Requires Attention**  
Operates causing 27 MHz interference
