Seaworthy Inspection Report

Date of Survey	17.09.2024 13:11 AEST
----------------	-----------------------

Reason For Survey	Pre-Purchase Survey
-------------------	---------------------

Vessel Make and Model	Haines Hunter 580 Breeze
-----------------------	--------------------------

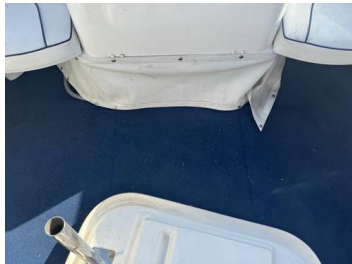
Photo 9

Main Floor/Deck

Fair

No significant cracks or damage were found. Additionally the floor was moisture tested with only low readings found. please note there was minor signs of flexing surrounding the seat bases and the carpet is not in pristine condition.

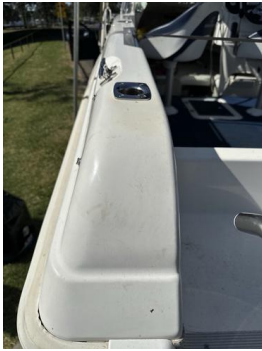
Photo 16

Side and Bow Decks

Fair

Please note structurally in satisfactory condition with no signs of significant damage found. Cosmetically the gelcoat is heavily oxidised and requires thorough buffing/polishing.

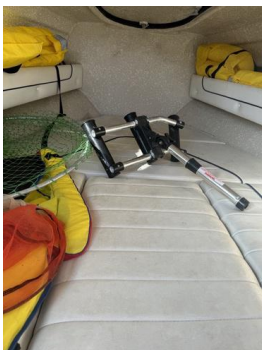
Photo 25

Seating and Trimming

Fair

Satan trimming in undamaged but dirty/stained condition.

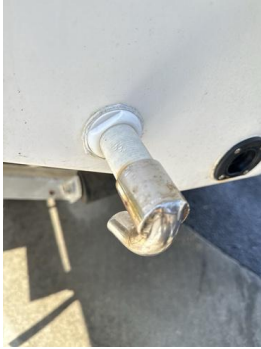
Photo 34

Sea Cocks, Skin Fittings and Hull Penetrations

Please note no sea cock fitted to live well pick up, recommend fitting one for safety purposes.

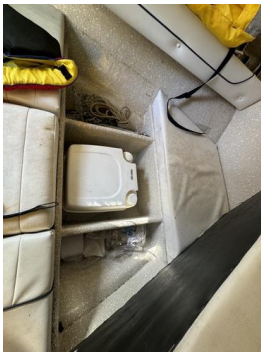
Photo 37

Doors, Windows, Lockers and Hatches

Please note loose fasteners for the hatch located centre of the deck.

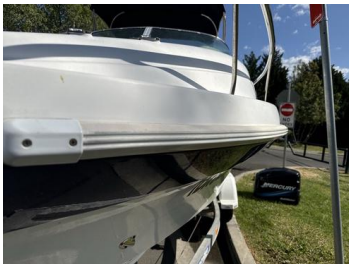
Photo 47

Rub Strip / Rails

Fair

Significant Rub, marks along the whole gunnel strip and a large gouge found mid ship port side.

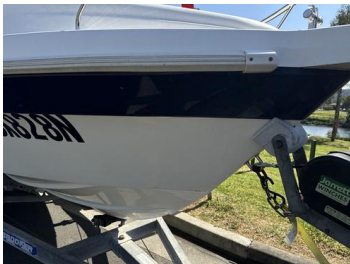
Photo 60

Hull Condition Above Waterline

Fair

Significant rub marks scratches and UV oxidation found on the hull above waterline. No indications of structural damage or heavy impact damage found.

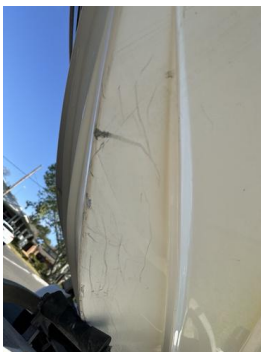
Photo 76

Hull Condition Below Waterline

Fair

Significant gouges chips and scratches below waterline were found primarily towards the bow of the vessel. Although currently not appearing to cause major structural damage immediate repair is recommended as well as repairs to the Trailer rollers that appear to be causing the majority of these issues.

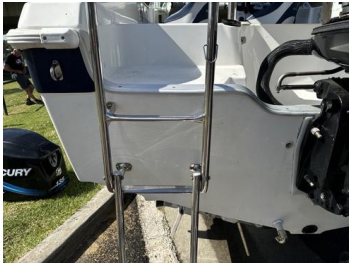
Photo 91

Transom Condition

Fair

Although no signs of cracking or significant damage was found when undertaking a percussion test there was slight indications of delamination in the transom as well as minimal flex when flex testing the engine.

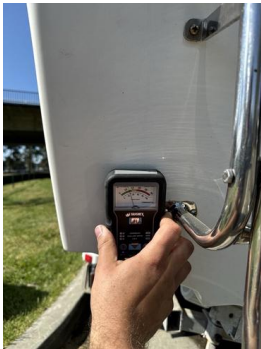
Photo 97

Transom Moisture Readings

Moderate

Moderate moisture ratings were found throughout the majority of the transom.

The Haines Hunter 580 Breeze, upon inspection, was found to be in structurally sound condition overall, though some areas require attention. The hull remains largely intact, with signs of significant damage to the keel, moisture was detected in the transom. While this does not pose an immediate structural concern, it should be monitored closely and addressed to prevent potential long-term deterioration.

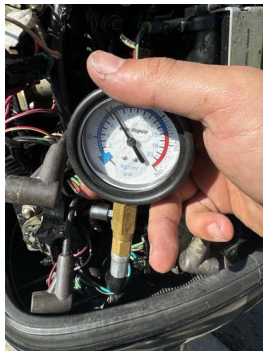
Photo 115

Cylinder Compressions (In Order)

106, 106, 110, 111, 110, 110,

Please note when removing the spark plug on the bottom cylinder of the port side bank significant resistance was felt when undoing it. When attempting to refit the spark plug a large amount of difficulty was found and upon further inspection. It appears as though at some point throughout the engines lifespan thread has been cross threaded. we were able to clean the threads and reinstall the plug but this is something that will have to be remembered during maintenance as any overtightening on these threads will result in stripping them as the threads are already compromised.

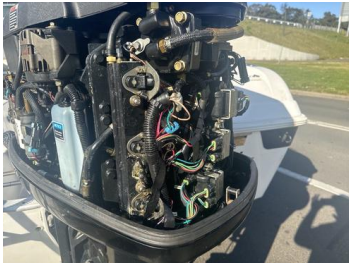
Photo 131

Engine Electrical Harness

Fair

Loose tape and conduit found on original harness, recommend repairs.

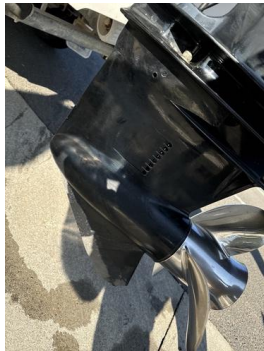
Photo 142

Gearcase Condition

Fair

Signs of heavy impact damage to the Skagg with a chunk of the Skagg now missing.

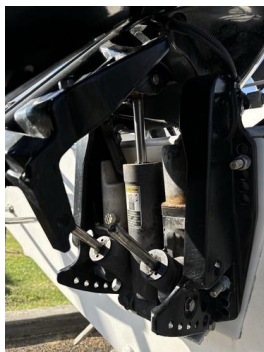
Photo 146

Trim and Tilt Operation and Indication

Fair

Minor corrosion found on trim pump.

Trim switch on engine works intermittently.

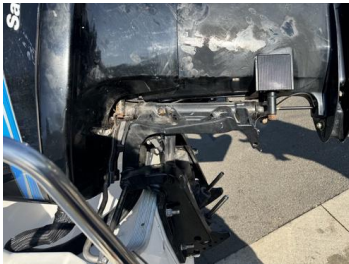
Photo 152

Engine Images/Evidence

Significant rust found on external parts of the engine. Please consult with a mechanic regarding required repairs.

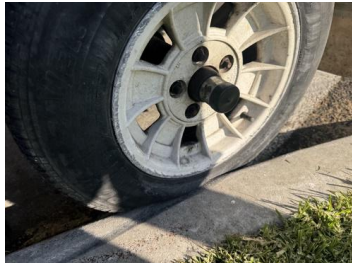
Photo 185

Wheels, Bearings and Rims

Fair

Wheels in satisfactory condition, with an unknown timeframe since Will bearings have been replaced replacement is recommended. Slight and moisture intrusion was found.

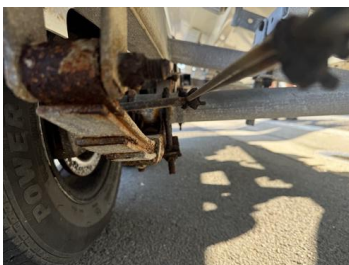
Photo 205

Suspension

Fair

Minor to moderate rust found on suspension components particularly U-bolt and fish plates.
