Seaworthy Inspection Report

Date of Survey	17.09.2024 13:11 AEST
----------------	-----------------------

Reason For Survey	Pre-Purchase Survey
-------------------	---------------------

Vessel Make and Model	Haines Hunter 580 Breeze
-----------------------	--------------------------

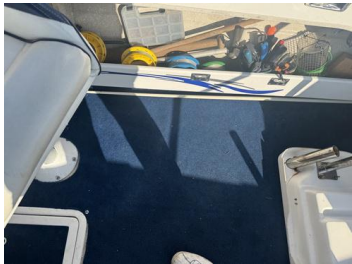
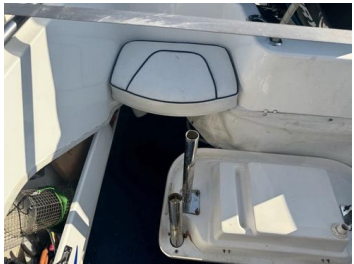
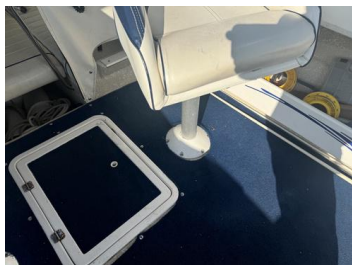
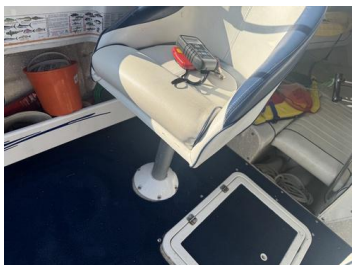
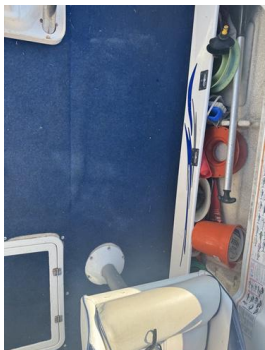
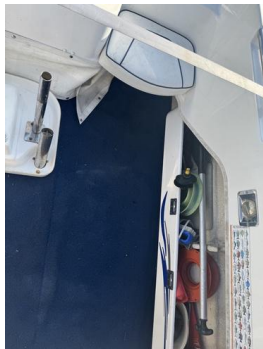
No significant cracks or damage were found. Additionally the floor was moisture tested with only low readings found. please note there was minor signs of flexing surrounding the seat bases and the carpet is not in pristine condition.

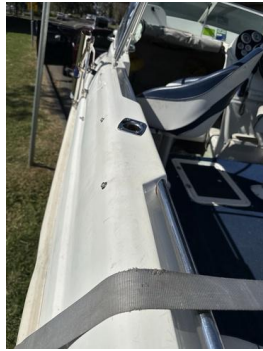
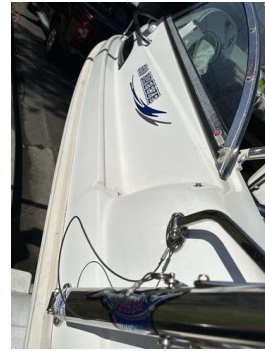
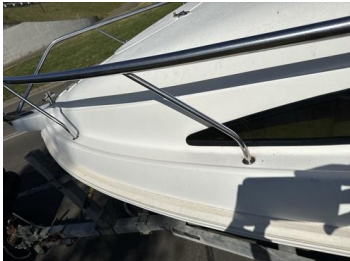
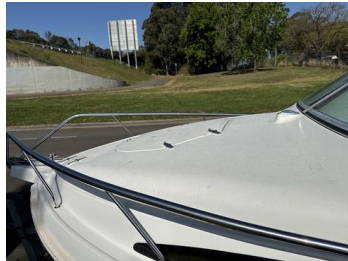
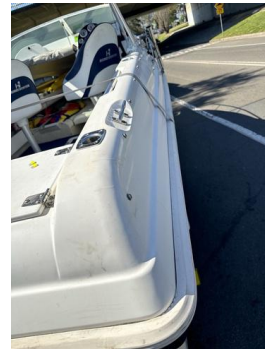
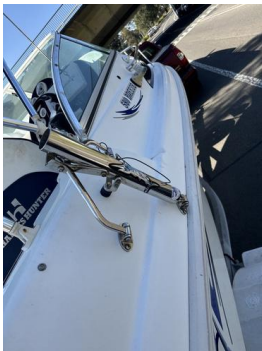
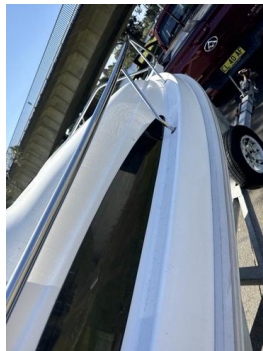
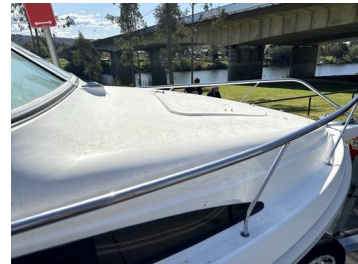
Side and Bow Decks

Please note structurally in satisfactory condition with no signs of significant damage found. Cosmetically the gelcoat is heavily oxidised and requires thorough buffing/polishing.

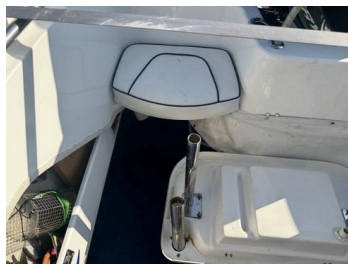
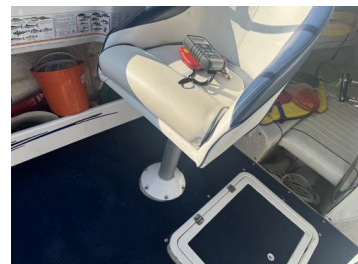
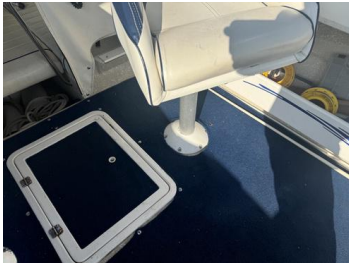
Seating and Trimming

Satan trimming in undamaged but dirty/stained condition.

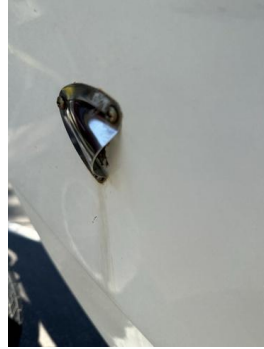
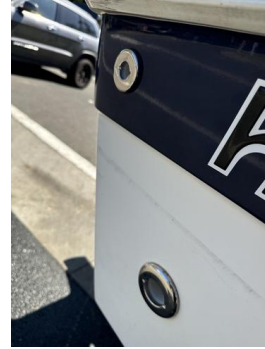
Sea Cocks, Skin Fittings and Hull Penetrations

Please note no sea cock fitted to live well pick up, recommend fitting one for safety purposes.

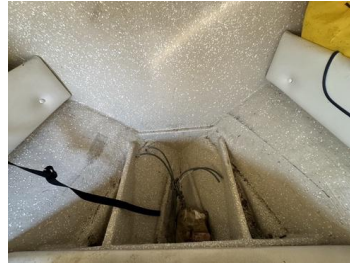
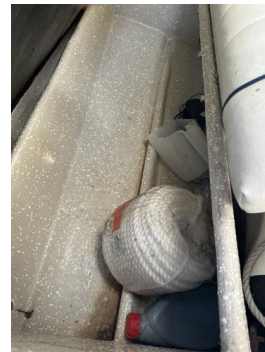
Doors, Windows, Lockers and Hatches

Please note loose fasteners for the hatch located centre of the deck.

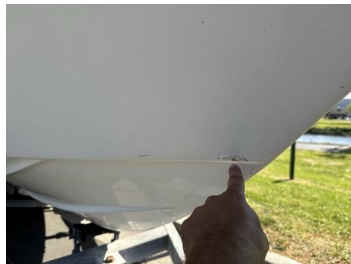
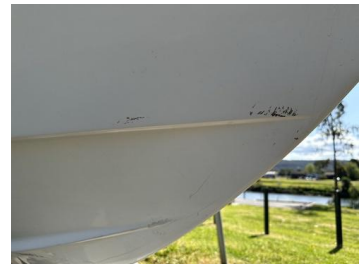
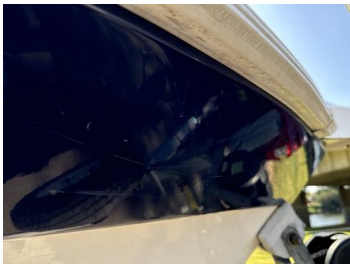
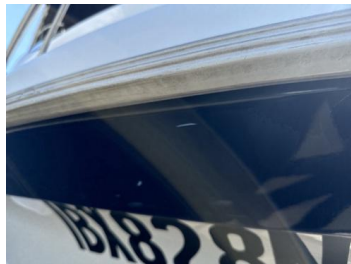
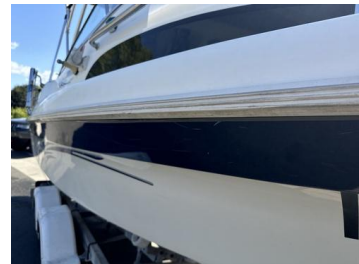
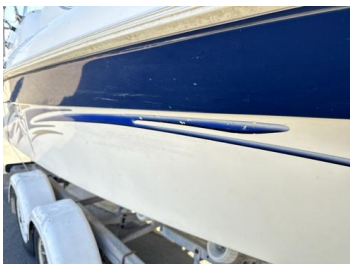
Hull Condition Above Waterline

Significant rub marks scratches and UV oxidation found on the hull above waterline. No indications of structural damage or heavy impact damage found.

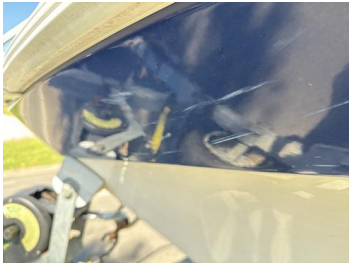
Photo 75

Hull Condition Below Waterline

Significant gouges chips and scratches below waterline were found primarily towards the bow of the vessel. Although currently not appearing to cause major structural damage immediate repair is recommended as well as repairs to the Trailer rollers that appear to be causing the majority of these issues.

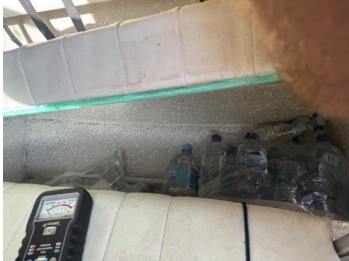
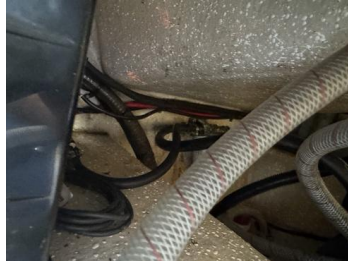
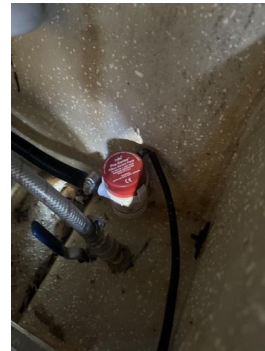
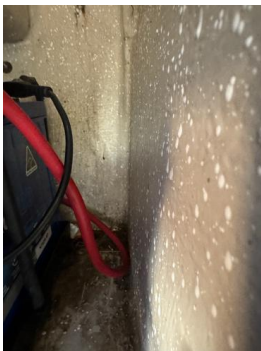
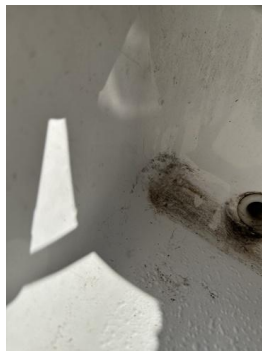
Hull Interior Condition - Frames/Stringers/Bulkheads

Satisfactory

No signs of significant damage found please note access is severely limited on these vessels to visually inspect these areas. Was able to be seen presented no signs of damage or heavy deterioration.

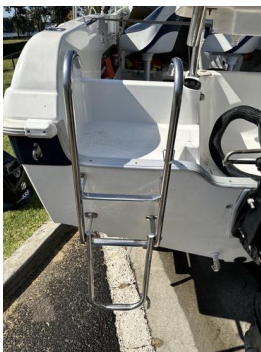
Photo 90

Swim Platform & Ladder

Satisfactory

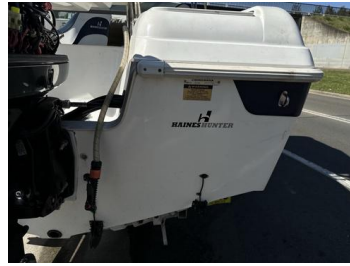
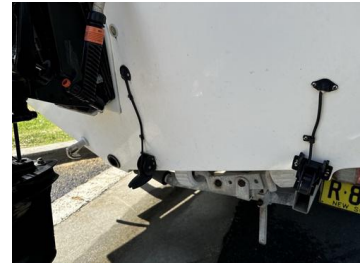
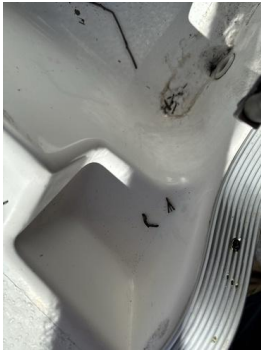
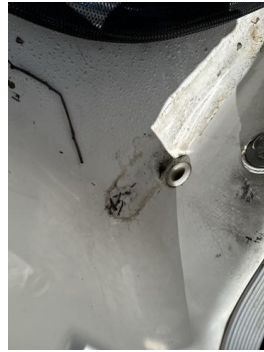
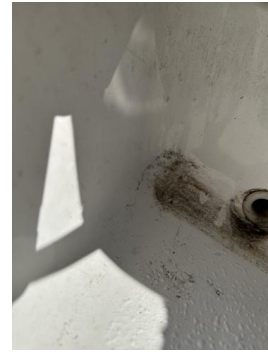
Transom Condition

Although no signs of cracking or significant damage was found when undertaking a percussion test there was slight indications of delamination in the transom as well as minimal flex when flex testing the engine.

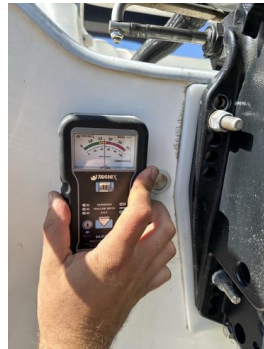
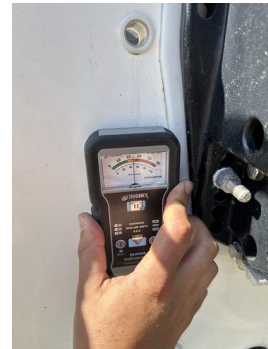
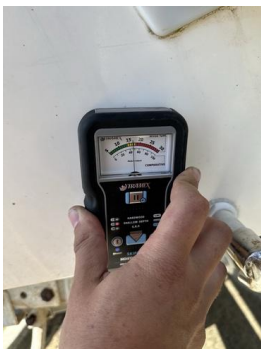
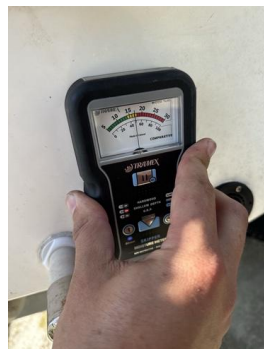
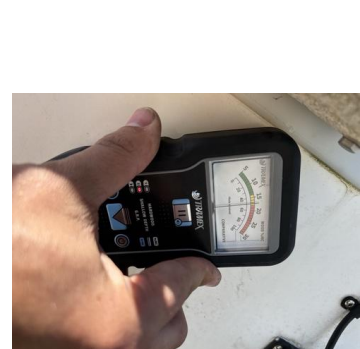
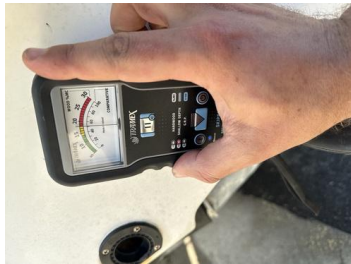
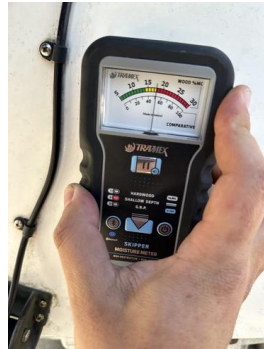
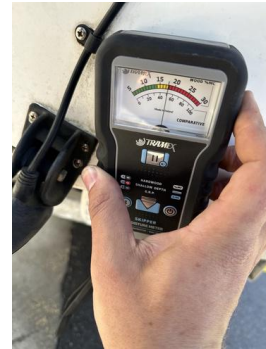
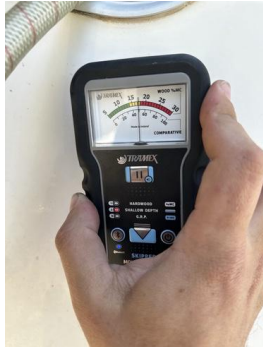
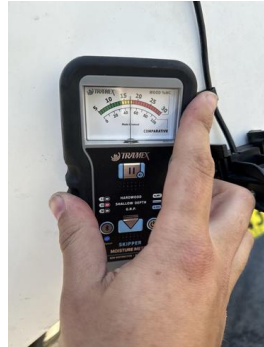
Transom Moisture Readings

Moderate moisture ratings were found throughout the majority of the transom.

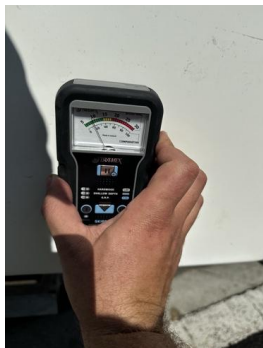
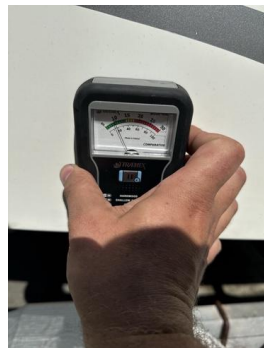
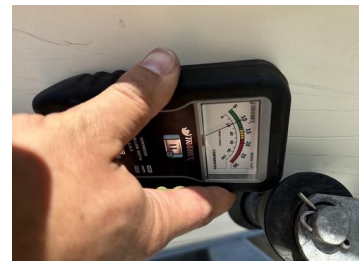
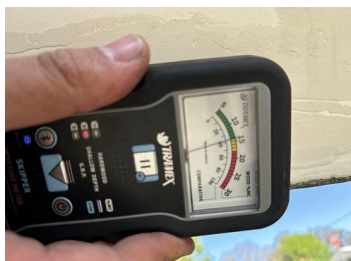
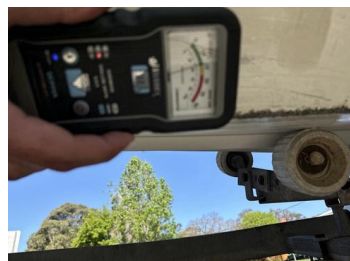
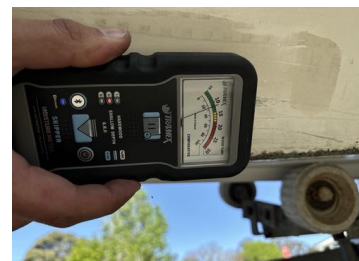
Hull Moisture Readings

Low

Primarily low readings were found throughout the rest of the hull, please note access was limited to some internal areas.

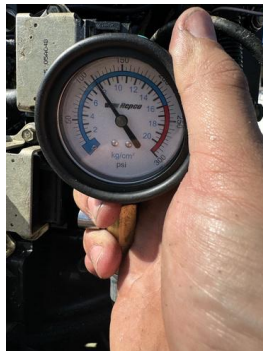
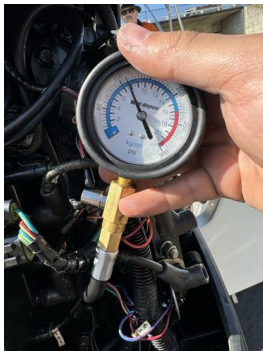
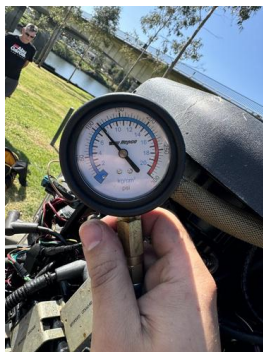
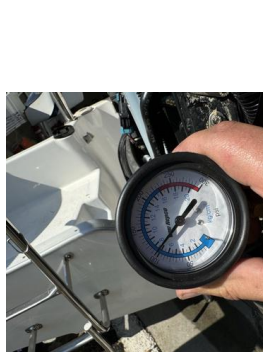
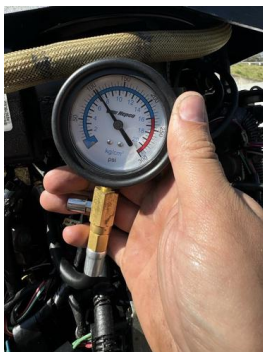
Please note when removing the spark plug on the bottom cylinder of the port side bank significant resistance was felt when undoing it. When attempting to refit the spark plug a large amount of difficulty was found and upon further inspection. It appears as though at some point throughout the engines lifespan thread has been cross threaded. we were able to clean the threads and reinstall the plug but this is something that will have to be remembered during maintenance as any overtightening on these threads will result in stripping them as the threads are already compromised.

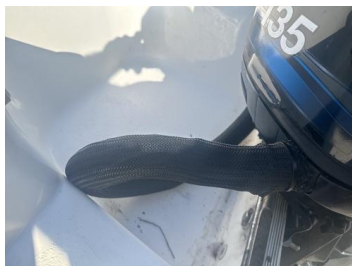
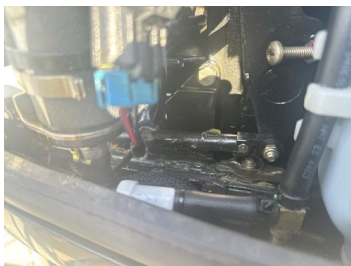
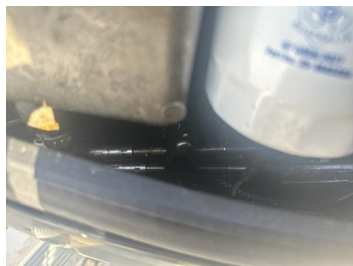
Engine Control Cables

Satisfactory

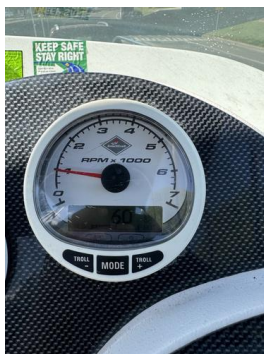
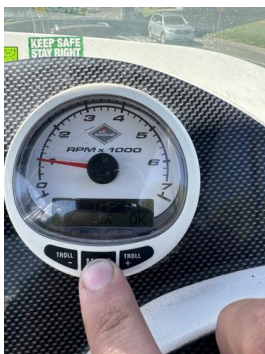
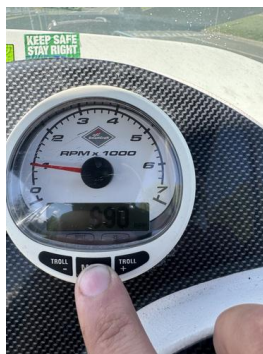
Engine Indication Systems

Satisfactory

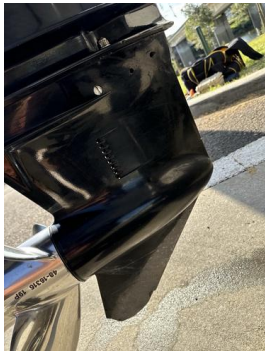
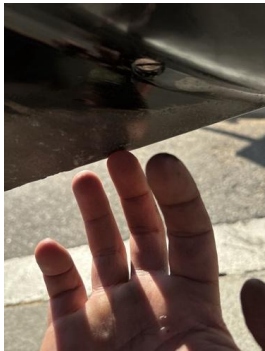
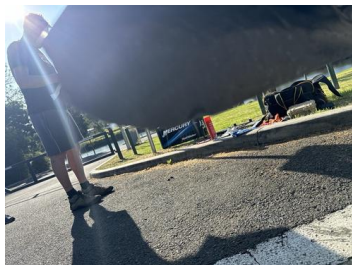
Signs of heavy impact damage to the Skagg with a chunk of the Skagg now missing.

Mechanically, the engine performed reasonably well, with no major deficiencies noted, though it is not in perfect condition. With impact damage to the skeg and wiring requiring tidying up. Routine maintenance and minor repairs may be necessary to optimize its performance. Similarly, the trailer is in good condition, though not without minor issues observed, which could benefit from preventative care to ensure longevity.

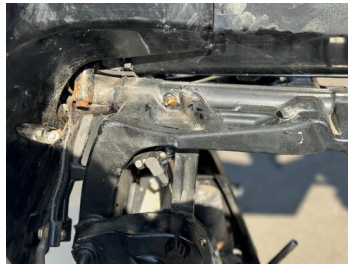
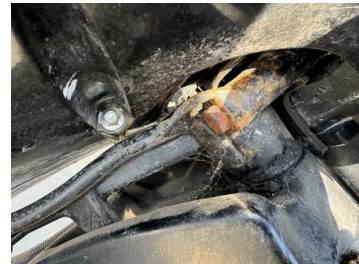
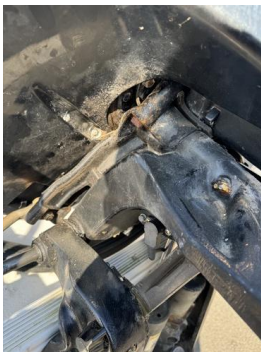
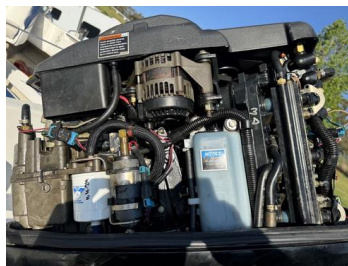
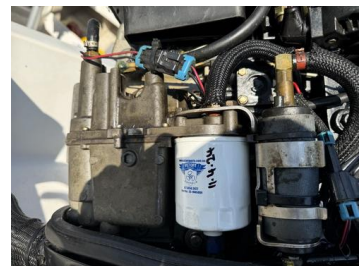
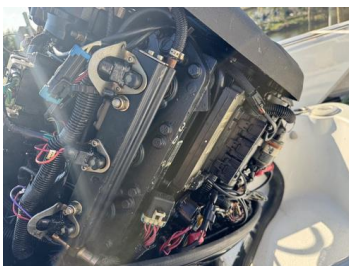
Significant rust found on external parts of the engine. Please consult with a mechanic regarding required repairs.

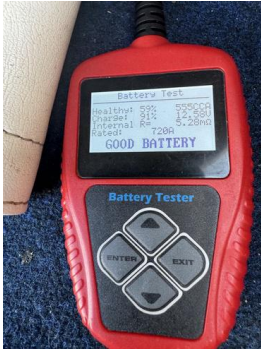
Photo 165

Port side battery came back as healthy unfortunately the starboard side battery had extremely low voltage and was unable to be tested with the meter.

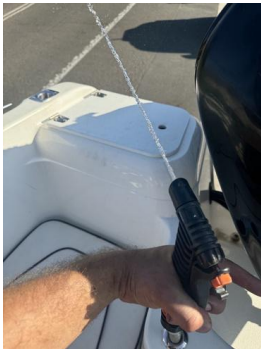
Photo 176

60 L poly tank with freshwater pump.

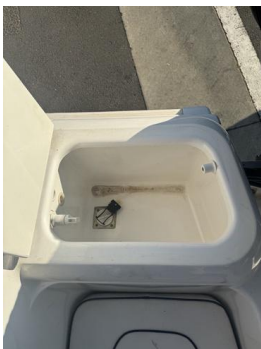
Photo 177

Pump functioned please note sea trial required for full testing

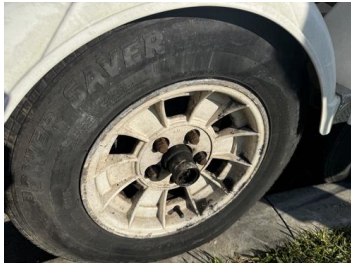
Photo 186

Wheels in satisfactory condition, with an unknown timeframe since Will bearings have been replaced replacement is recommended. Slight and moisture intrusion was found.

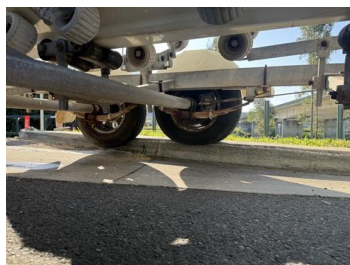
Photo 206

Minor to moderate rust found on suspension components particularly U-bolt and fish plates.
